RE: Attached FEMA Report Excerpts

BUILDING PERFORMANCE: HURRICANE ANDREW IN FLORIDA

OBSERVATIONS, RECOMMENDATIONS,
AND TECHNICAL GUIDANCE

EXECUTIVE SUMMARY

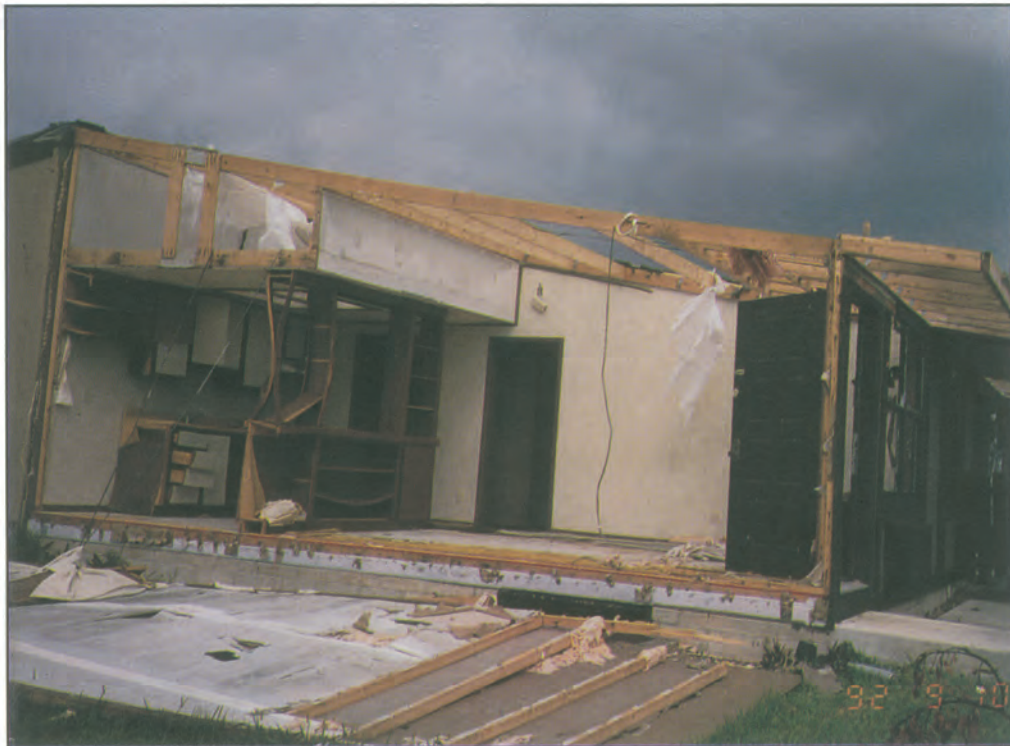
Two end-wall (end wall of end modules) failures were observed in a modular home subdivision. Poor connection of the tops of the walls to the roof diaphragms was evident in these instances. Some roof sheathing was observed missing from rafters, judged to be due either to building envelope breach (window and/or door failure) or to external wind and debris. Generally, the rafters themselves were left entirely intact, because of the inherent rigidity developed by the relatively short spans and secure connections. (SEE FIGURES 19 AND 20.)

FIGURE 19. *Modular home. End wall of end unit separated from unit; withdrawal of nails along eave line and roof sheathing failure were also observed.*

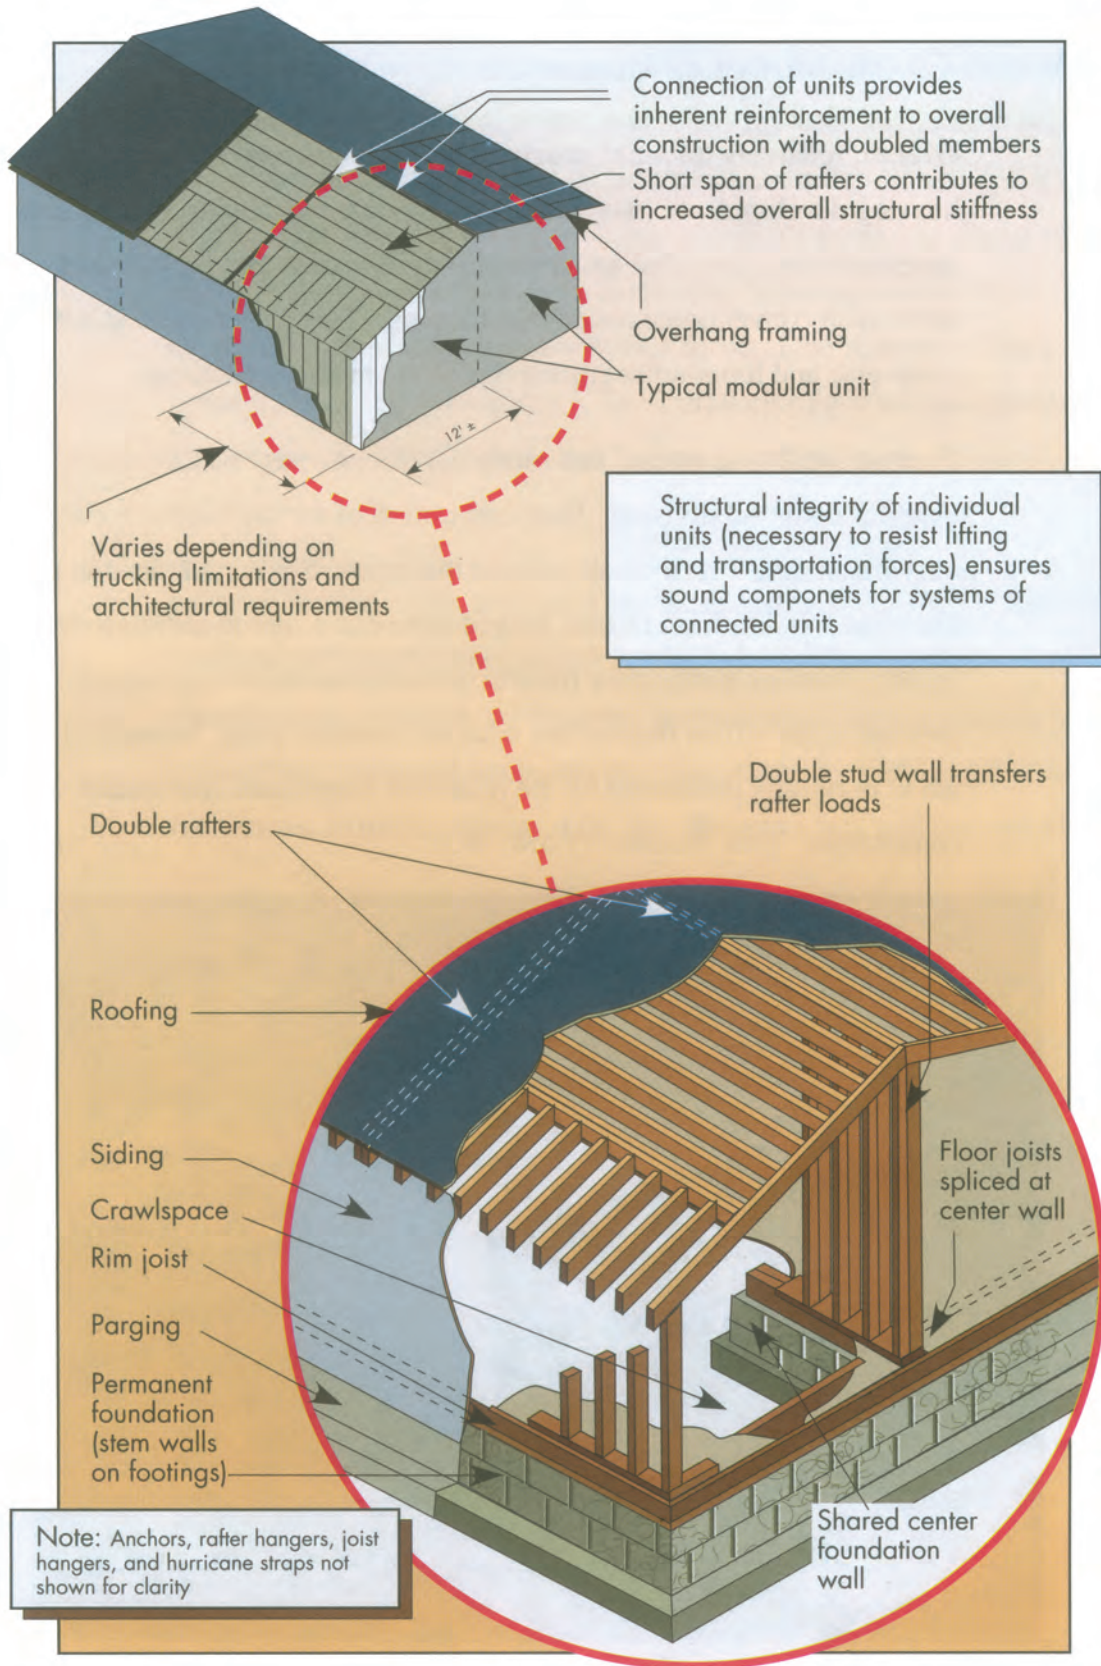
Overall, relatively minimal structural damage was noted in modular housing developments. The module-to-module combination of the units appears to have provided an inherently rigid system that performed much better than conventional residential framing. This was evident in both the transverse and longitudinal directions of the modular buildings.

FIGURE 20. *Inherent structural strength of modular construction.*

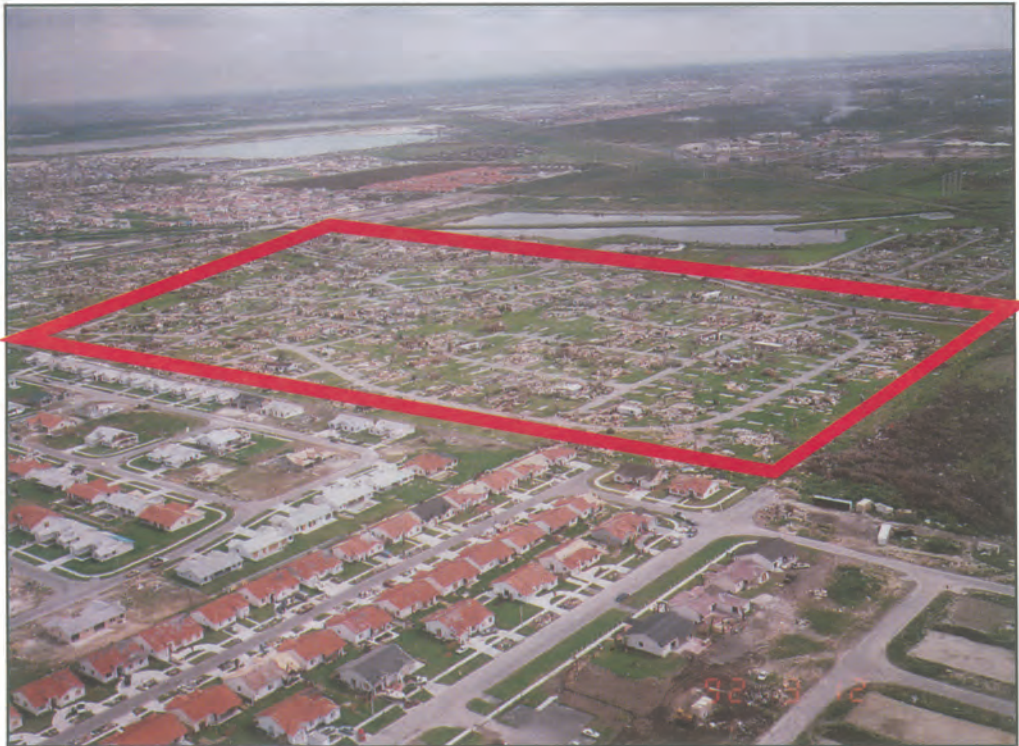
Manufactured homes possessed poor ability to withstand the high wind loads generated by Hurricane Andrew (SEE FIGURE 21). In several subdivisions, many of these homes suffered total losses.

FIGURE 21. Aerial photo of damage area. Shows building performance difference between manufactured homes (outlined in center) and conventional residential buildings (lower left).
